Tree Hazard Assessment Report

22 October 2021

The Oasis
45 Lindsay Road
Poole
BH13 6AP

TS/12221/AC

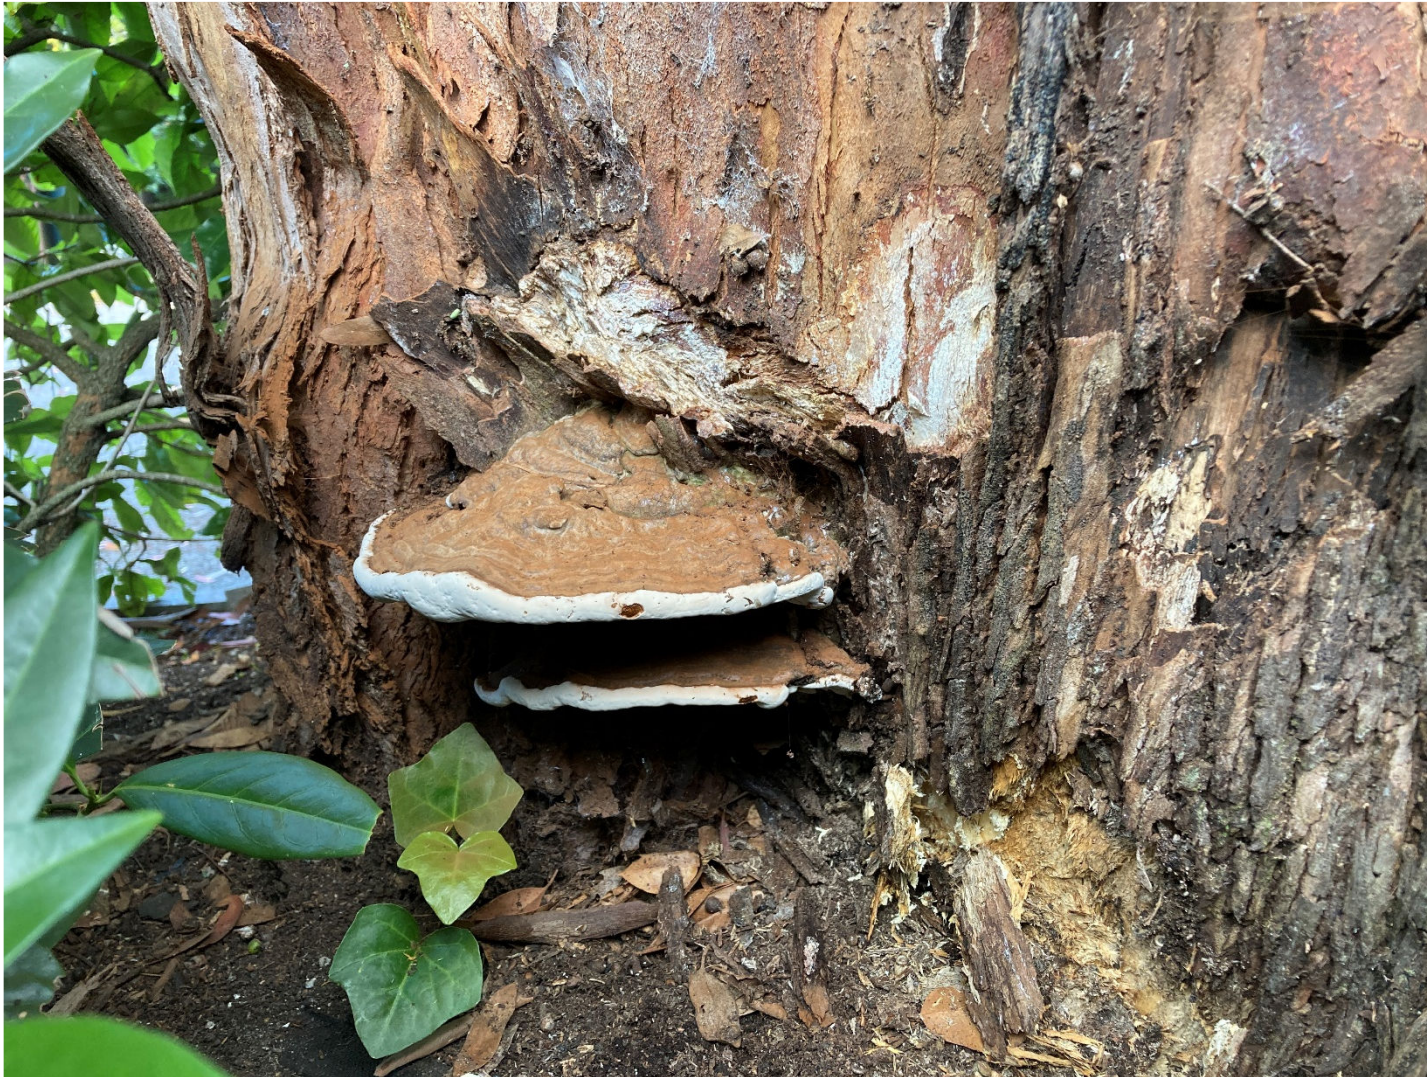
Pic.1

Tree No	Species	Life Stage	Observations & Appraisal	Recommendations	Work priority
1 (G7)	Eucalyptus	Early mature	<p>Stem leans at 45 degrees to northwest. Large buttress roots on southeast side are lifting kerb and disrupting tarmac surface – approx. 150mm lift above surrounding ground. Large fungal fruit bodies (<i>Ganoderma</i> sp.) at base of stem – 2 on west side 200mm diameter, 1 each on south and east side. Crown reduced in past, large obvious pruning cuts visible.</p> <p><i>Ganoderma</i> sp. is an aggressive decay fungus that causes a white rot at the base of stems, which can result in stem failure. The fact that the tree leans heavily means that there is considerable stress on the lower stem, compounding any weakening effect from the fungus. The presence of fruit bodies on three sides of the stem indicates that the fungus has thoroughly colonised the tree and the decay is therefore unlikely to be isolated. The likelihood of failure is therefore high enough to require significant intervention.</p> <p>The tree is a poor-quality specimen which has been subject to some poor pruning work in the past and this, combined with the serious disruption to the driveway surface, means that pruning to try and reduce the likelihood of failure would not be worthwhile. Felling the tree and planting a replacement is therefore the appropriate option.</p>	<p>Fell to ground level and plant replacement tree. See Pic. 1, overleaf.</p>	Moderate 1

Ganoderma fruit bodies on lower stem of eucalyptus T1

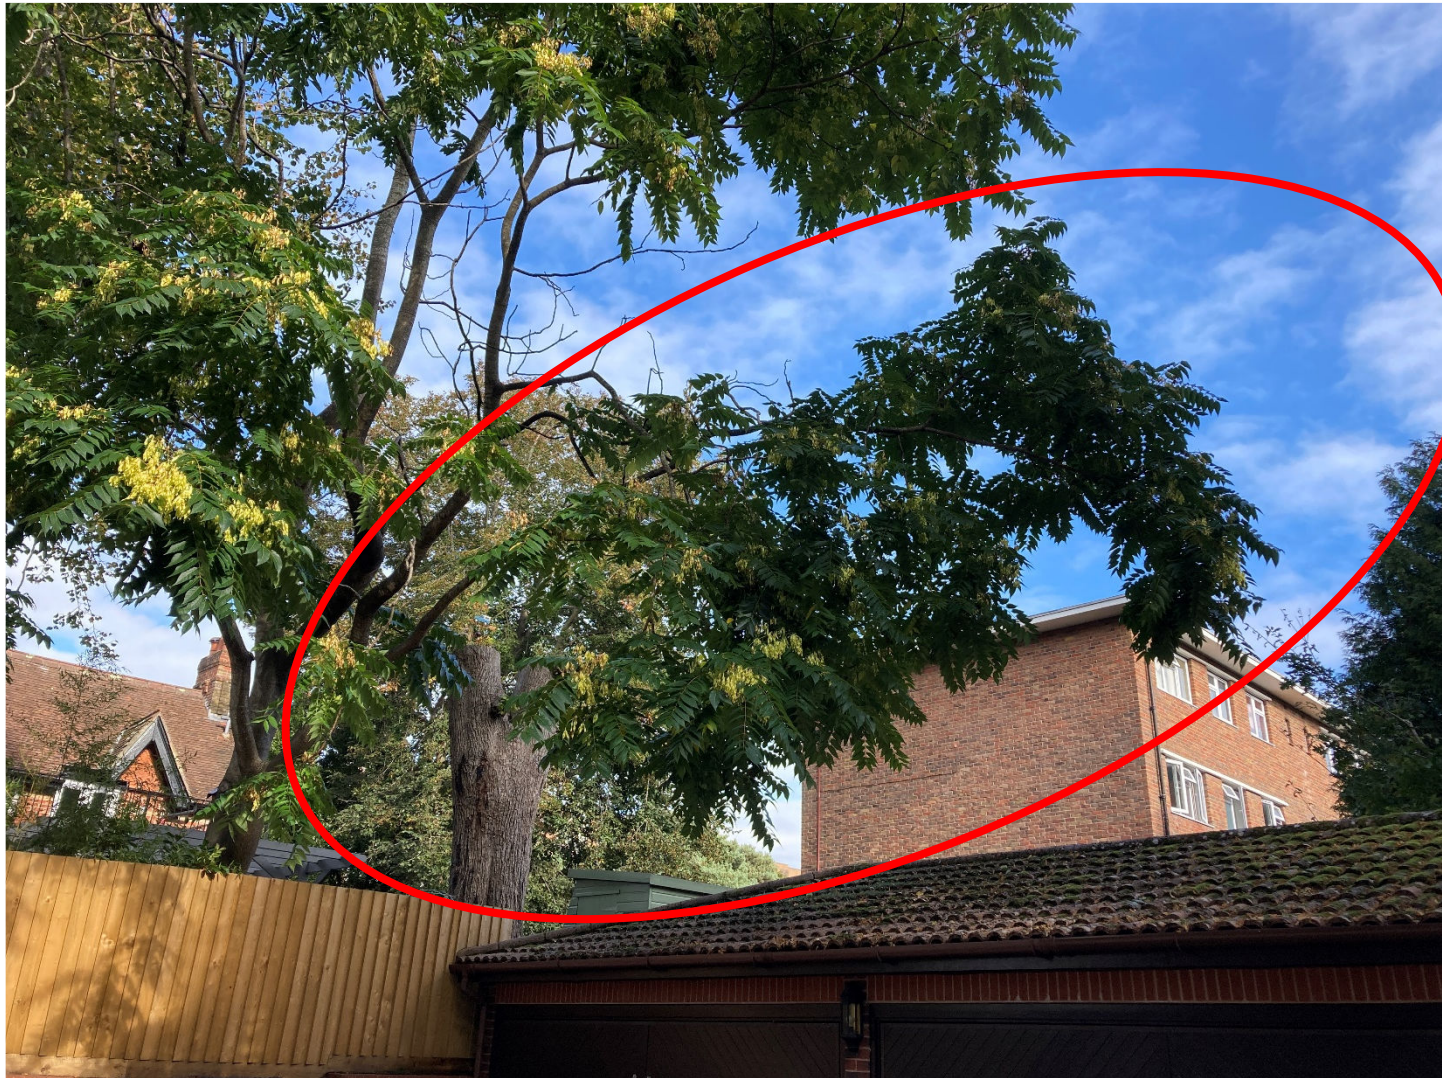
Pic.2

Low branches of tree of heaven T8

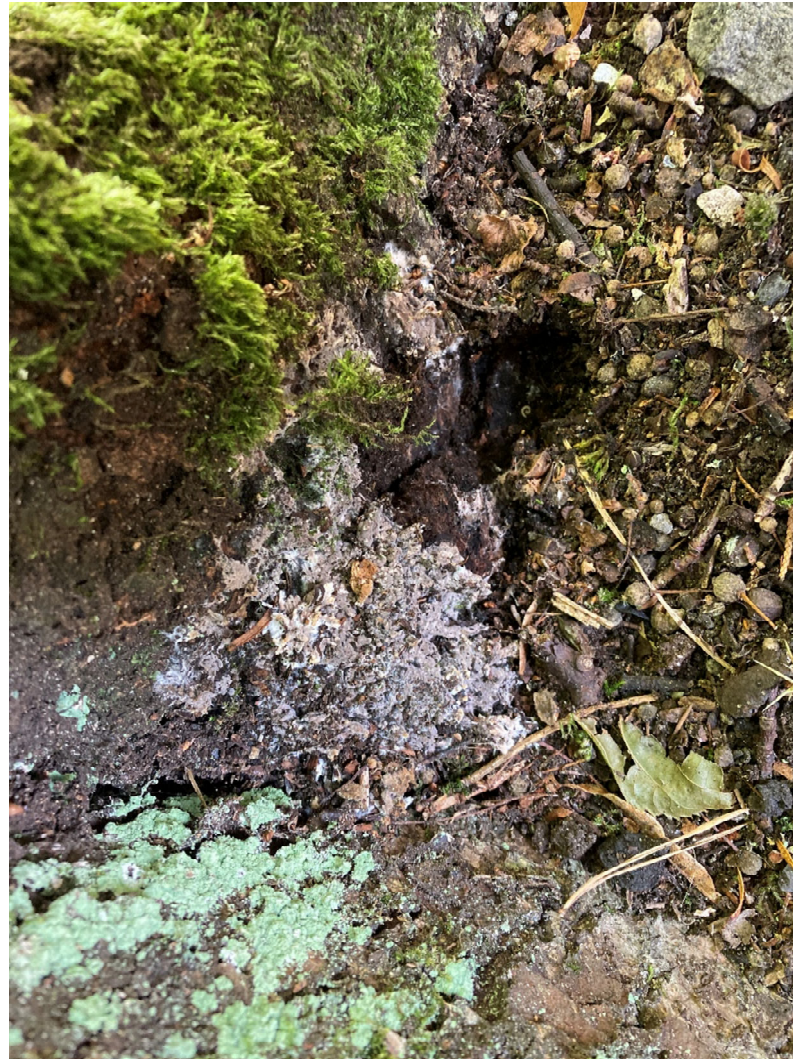
Pic.4

Tree No	Species	Life Stage	Observations & Appraisal	Recommendations	Work priority
4 (T5)	Norway maple	Early mature	Low branches overhanging adjacent garage block.	Prune lower branches to give 2m clearance from building.	Moderate 1
5 (G1)	Ash	Semi mature	Mostly dead.	Fell to ground level and plant replacement tree.	Moderate 2
6 (T10)	Lime	Early mature	Low branches overhanging adjacent parking spaces.	Prune lower branches to give 3m clearance above parking spaces.	Moderate 1
7 (T11)	Norway maple	Early mature	Low branches overhanging adjacent parking spaces.	Prune lower branches to give 3m clearance above parking spaces.	Moderate 1
8	Tree of heaven	Early mature	Low branches overhanging adjacent garages – long and heavily end-weighted. Resident reports they droop very low when it rains.	Remove low branches overhanging garage. See Pic. 2, overleaf.	Moderate 1
9 (G2)	Lime	Early mature	Low branches over adjacent garage. Secondary stem from base enveloped in buttresses of main stem. Fungal fruit body (<i>Kretzschmaria deusta</i>) between buttresses on northwest side at ground level. K. deusta is an aggressive decay pathogen which can cause brittle fracture of tree stems. Generally, once fruit bodies have appeared the decay has already progressed to a point where likelihood of failure is unacceptably high.	Fell to ground level and plant replacement tree. See Pics. 3 & 4, overleaf.	Moderate 1

Close up of *K. deusta* fruit body at base of lime T9

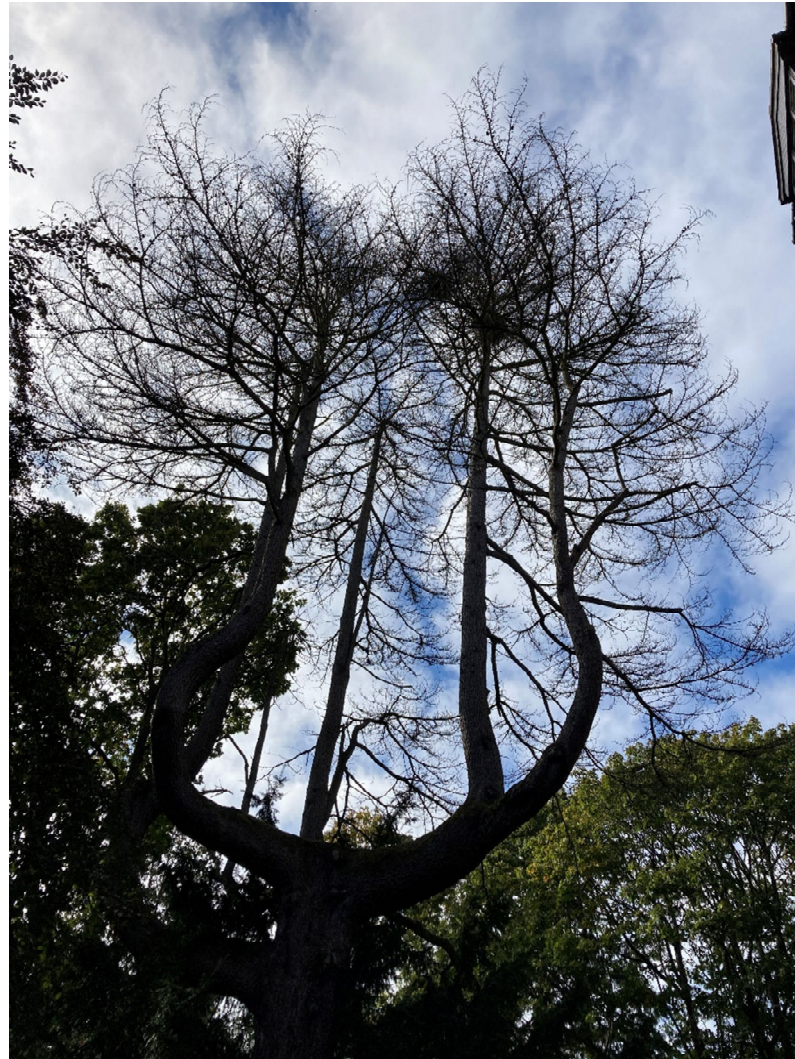
Pic.5

Dead cedar T15

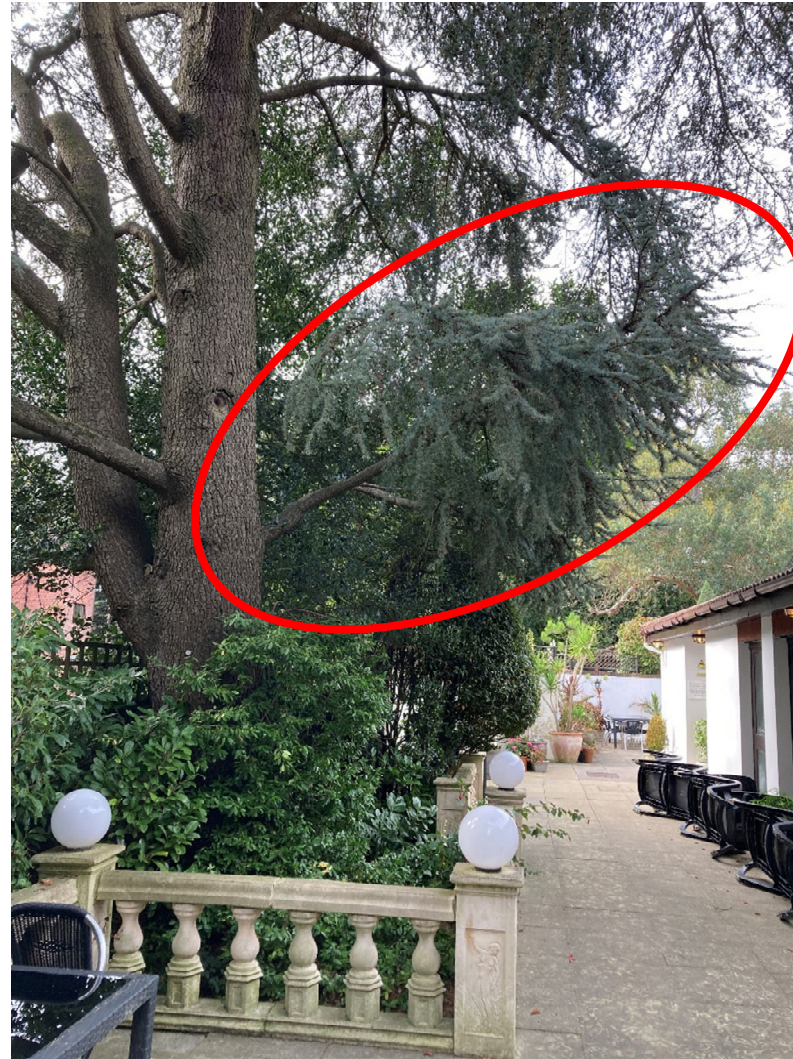
Pic.6

18 (G5)	Lime	Early mature	Low branches overhanging footpath.	Prune lower branches to give 3m clearance above footpath.	Moderate 1
19 (T14)	Blue Atlas cedar	Early mature	Low branches near roof of adjacent building and overhanging footpath.	Remove low pair of branches. See Pic. 6, overleaf.	Moderate 1

Branches to be removed from cedar, T19
